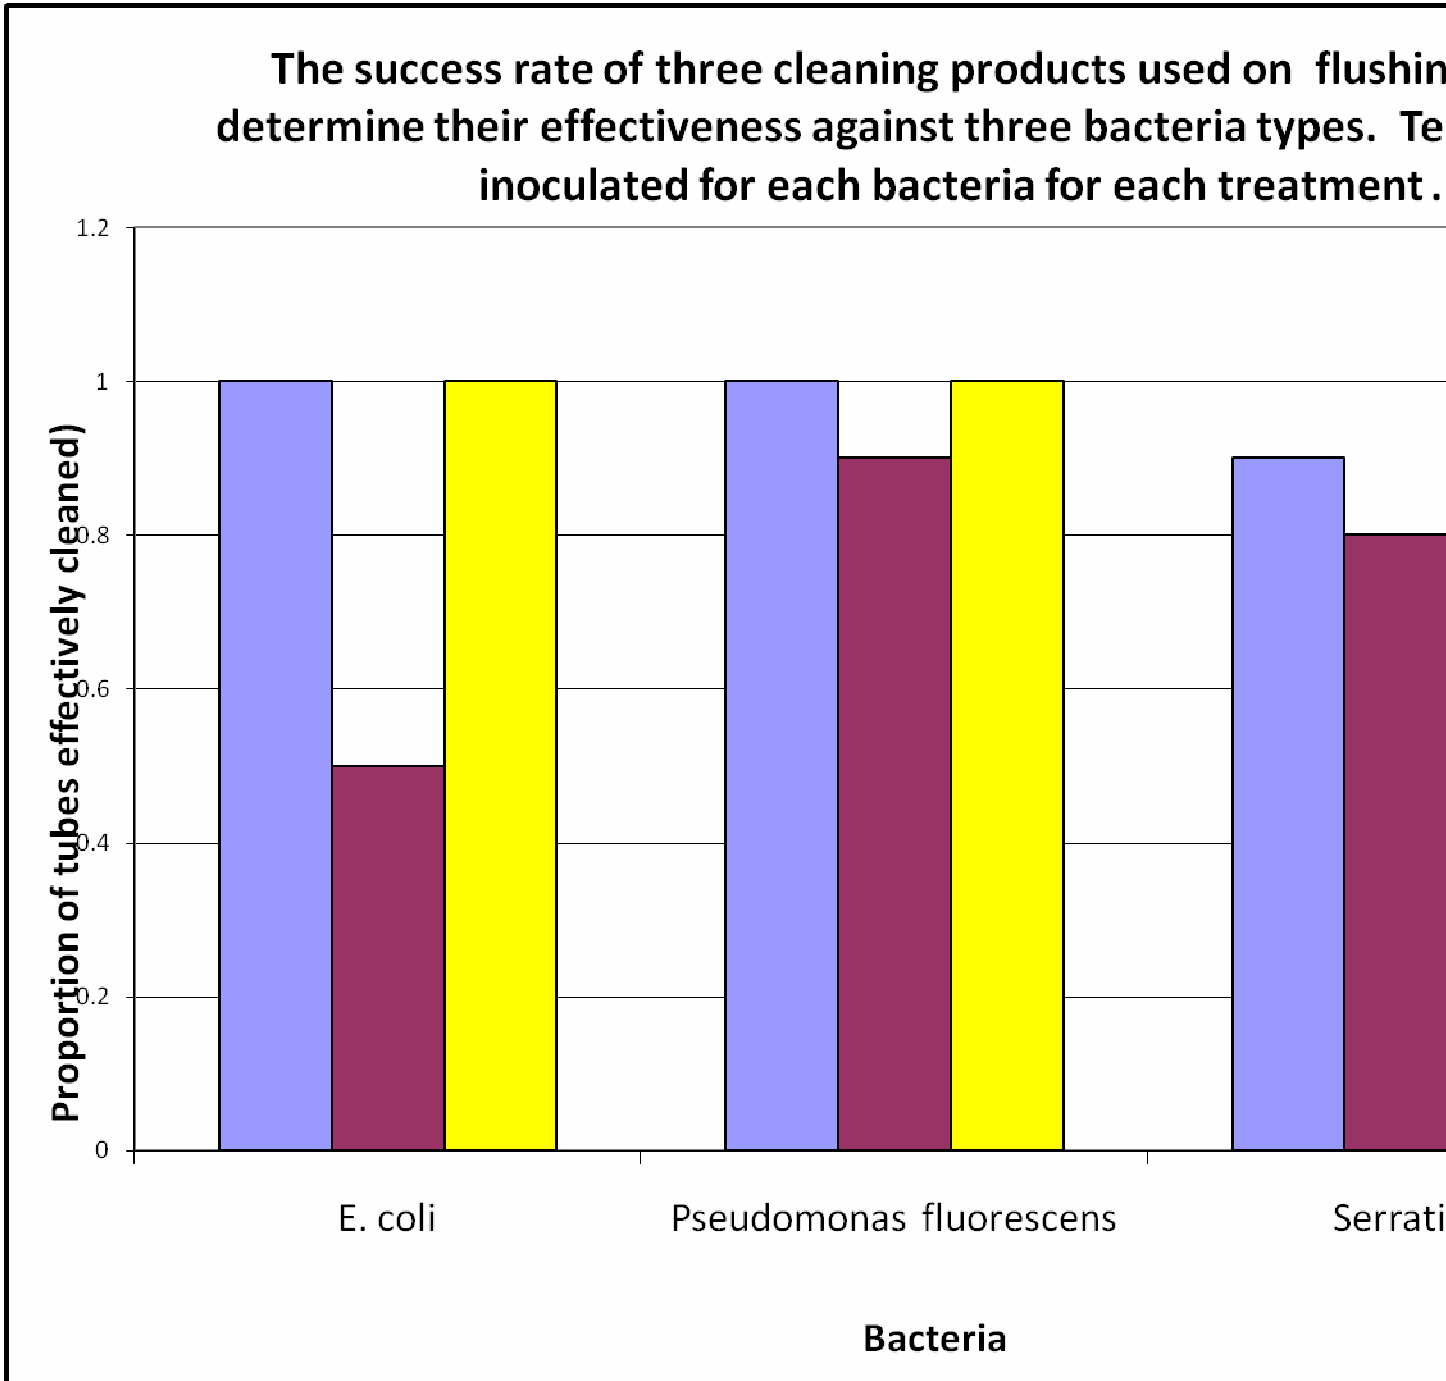
Figure 2. Comparison of the effectiveness of three cleaning products to remove three known bacteria from a stomach flushing tube.
